Transmission towers flattened by

EF4 tornado

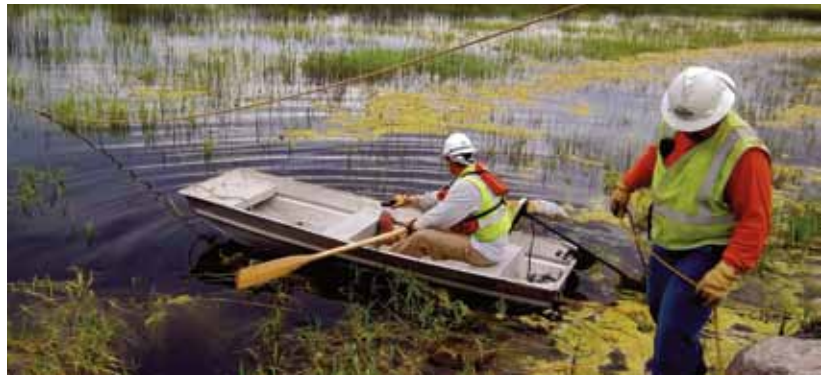
Paul Taylor (in boat) and Vince Smith work to pull a rope across a 1,200-foot wide body of water. The rope is used to pull strawline between two towers on either side of the water. Strawline is cable used to help string and tension conductor.

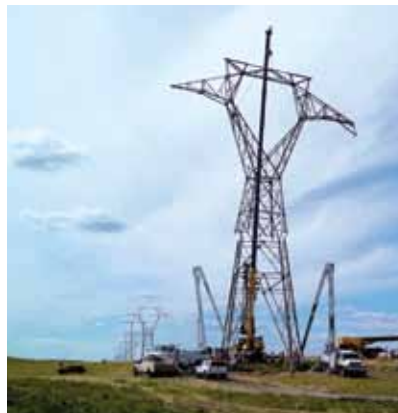
TSM crews assemble the towers in sections and lift them into place.

Crews used three mobile cranes to erect new structures. Deploying the cranes in soggy conditions required some innovative thinking by the TSM crews. "Our big Grove crane weighs

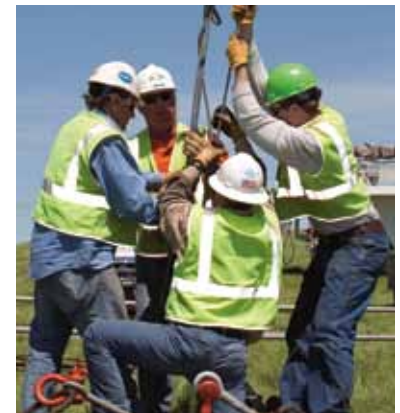
(From left) Jon Sherwood, Jay Ritter, Shane Homan and Paul Taylor secure the conductor so repairs can begin.

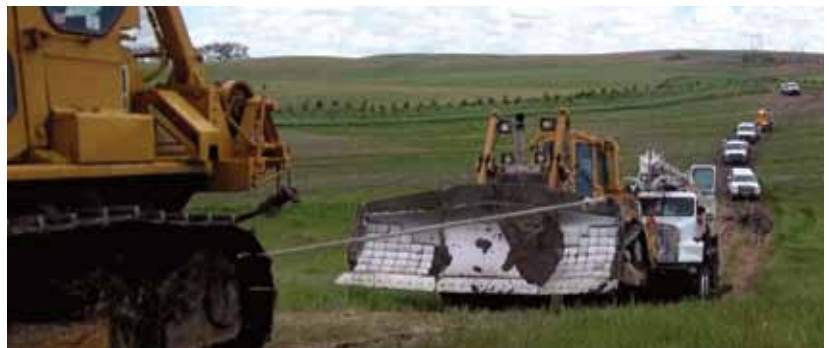
Overcoming the muddy terrain took some slick thinking by TSM crews. They used two bulldozers and a skid plate to pull equipment like this digger derrick truck into place.

Keller says one of their biggest challenges was dealing with the muddy conditions. "What wasn't already standing wetlands was saturated because of the spring runoff and precipitation," he says.

about 95,000 pounds with the counterweights in place. They built a skid, parked the crane on it, and used two Caterpillar dozers to drag the crane into place.”
